Advanced Multifunctional Coating

presented at 2011 Air Force Corrosion Conference

by
John DeAntoni
Boeing Research & Technology
314-232-2198
john.r.deantoni@boeing.com
17 August 2011

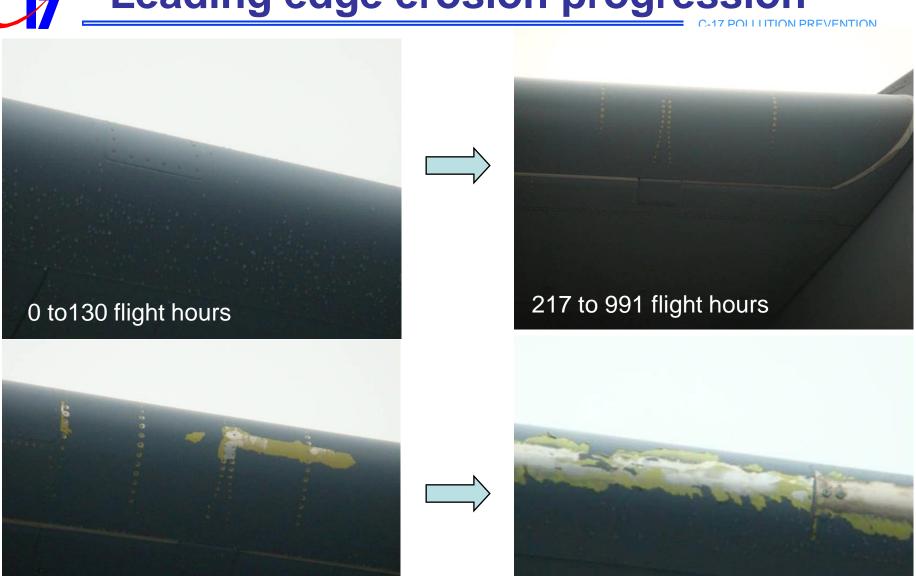
Leading edge erosion progression

291 to 1521 flight hours

> 2500 flight hours

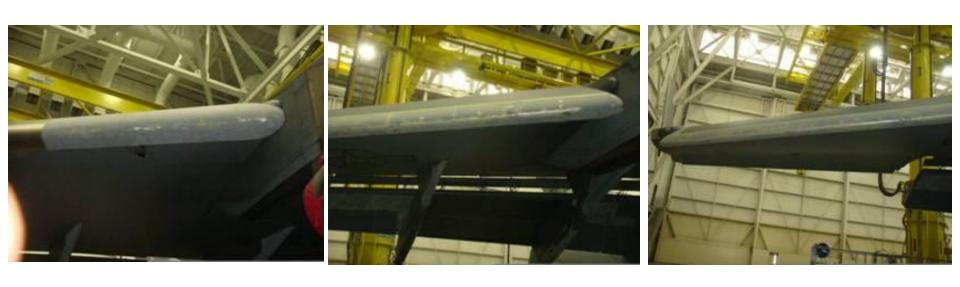
P-87 After Sanding

Test wing right side slats 2, 3 and 4 after sanding with 120 and 220 grit sand paper

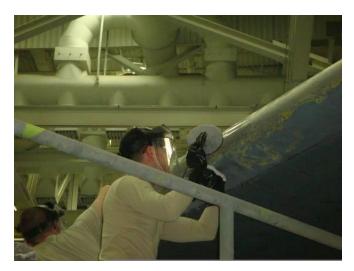
Alodine kit

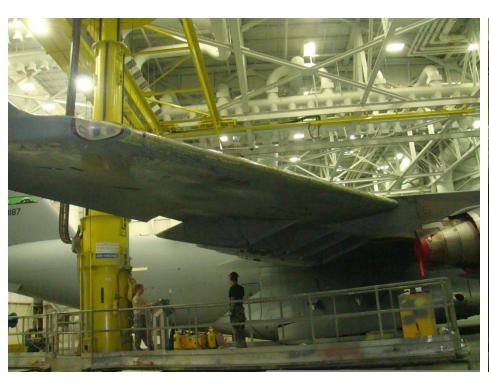
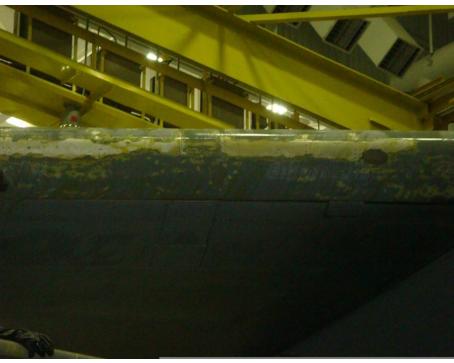
P-87 Alodine Process

Test slats after alodine process

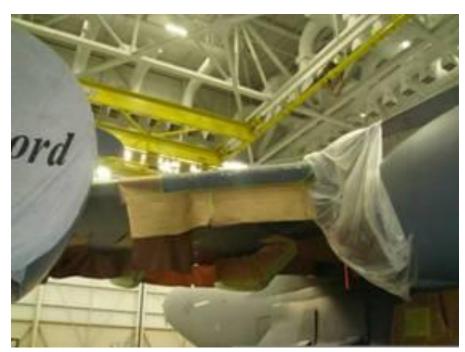
P-87 Paint Process

Test slat after masking

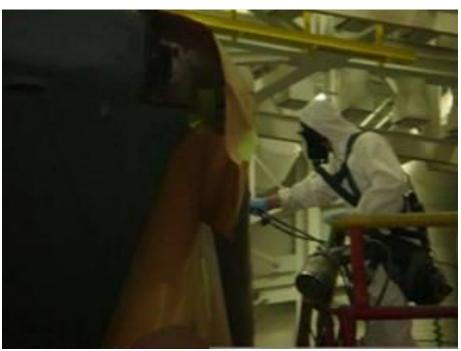
TSgt Nowak applying AMC

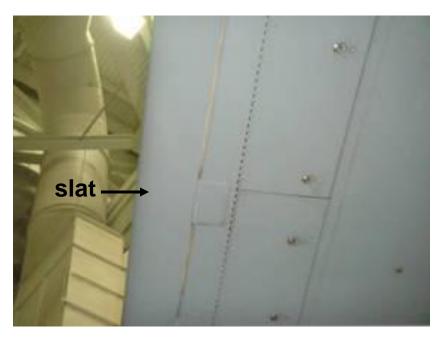
P-87 Process

Good color match of AMC with wing

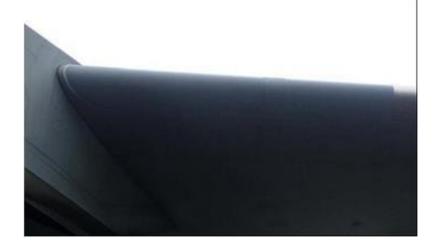
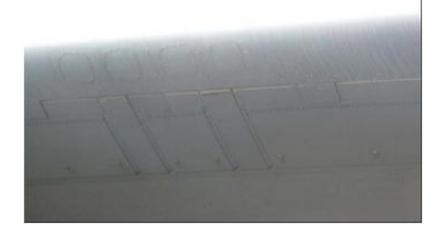
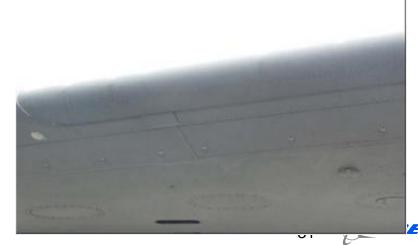
P-87 after 1064 Flight Hours

No discrepancies either wing

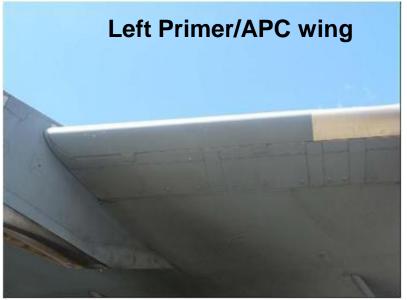
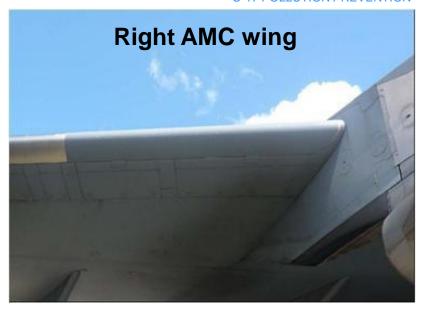
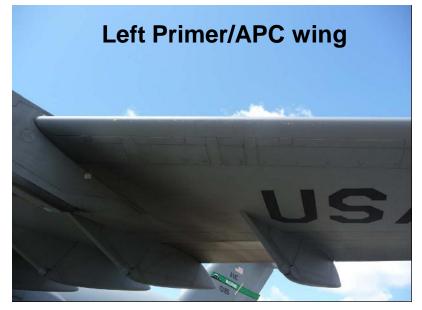
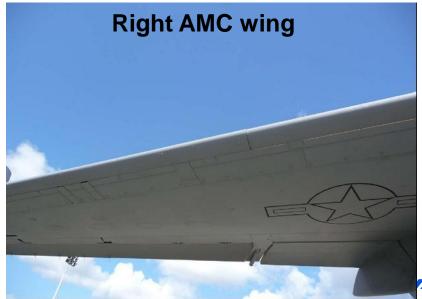
P-86 after 1306 Flight Hours No discrepancies either wing

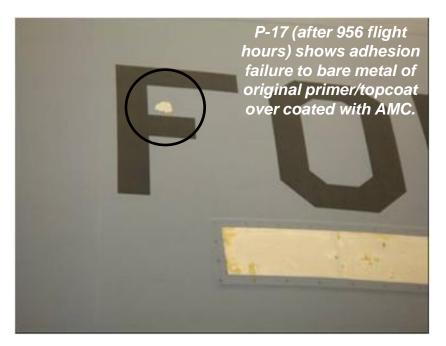
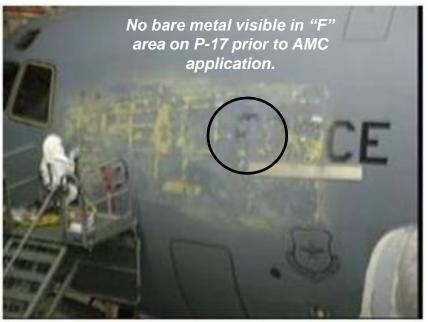
Discrepancy on P-17 after 956 Flight Hours

Discrepancy found during inspection at Warner Robins

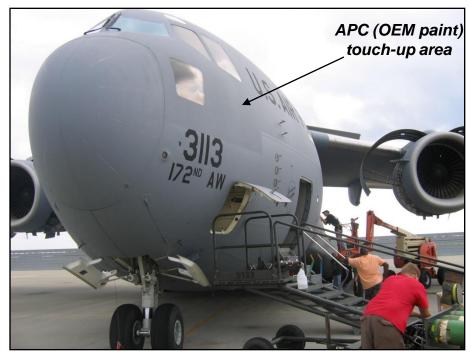
P113 recently touched-up with APC.
